SUPPLEMENTARY MATERIAL

Incorporating remote sensing techniques to the DRASTIC index to assess groundwater vulnerability at mining areas: application to Sonora river aquifer, northwestern Mexico

Publicado en Revista Mexicana de Ciencias Geológicas, v. 39, núm. 3, 2022, p. 248-261.

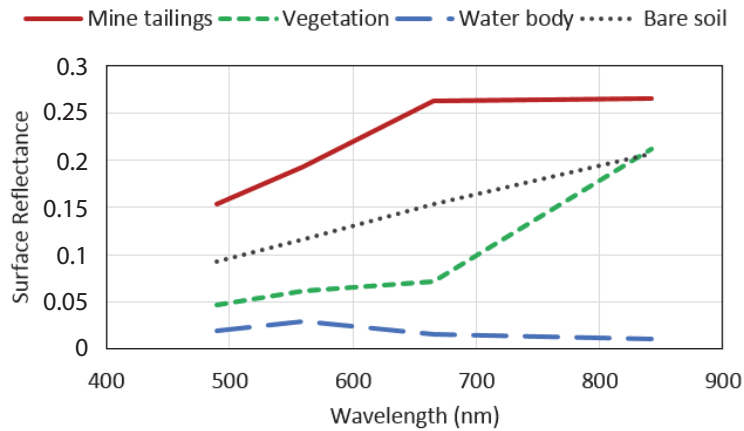
Figure SI.5. Spectral curves for representative surface features in the Sentinel 2 image.
